**DEPARTMENT OF TRANSPORTATION**

Contract #: 04-0120F4Cty: SF/ALA Rte: 80 PM: 13.2/13.9File #: 73.28**WELDING INSPECTION REPORT****Resident Engineer:**Pursell, Gary**Address:** 333 Burma Road**City:** Oakland, CA 94607**Report No:** WIR-006638**Date Inspected:** 06-May-2009**Project Name:** SAS Superstructure**OSM Arrival Time:** 800**Prime Contractor:** American Bridge/Fluor Enterprises, a JV**OSM Departure Time:** 1800**Contractor:** HoChang, Korea**Location:** Unyang/Changwon, Korea**CWI Name:** Sang Ho, Kwak**CWI Present:** Yes No**Inspected CWI report:** Yes No N/A**Rod Oven in Use:** Yes No N/A**Electrode to specification:** Yes No N/A**Weld Procedures Followed:** Yes No N/A**Qualified Welders:** Yes No N/A**Verified Joint Fit-up:** Yes No N/A**Approved Drawings:** Yes No N/A**Approved WPS:** Yes No N/A**Delayed / Cancelled:** Yes No N/A**Bridge No:** 34-0006**Component:** Pier E2 bearing and Shear key**Summary of Items Observed:**

The following report is based on METS observations at HoChang Machinery Industries (HCMI). Current work: Casting, forging and machining.

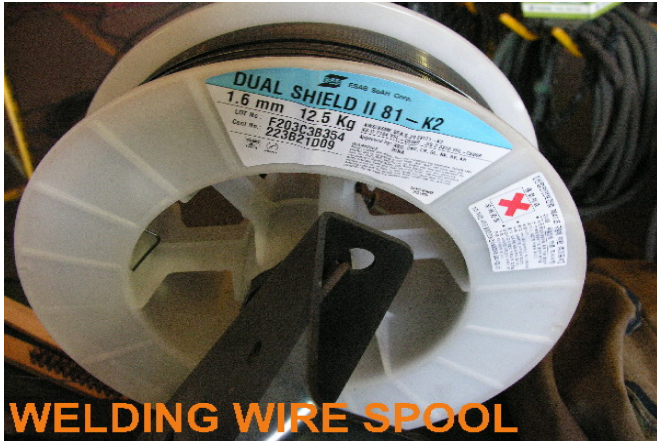
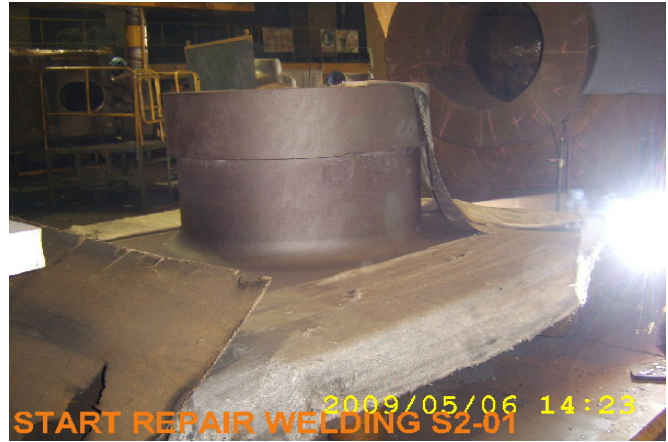
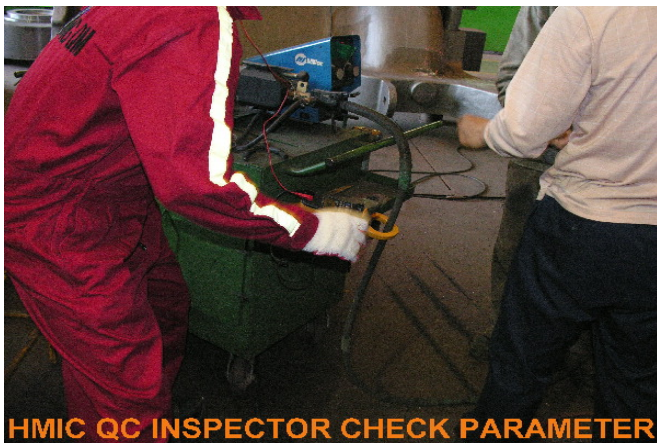
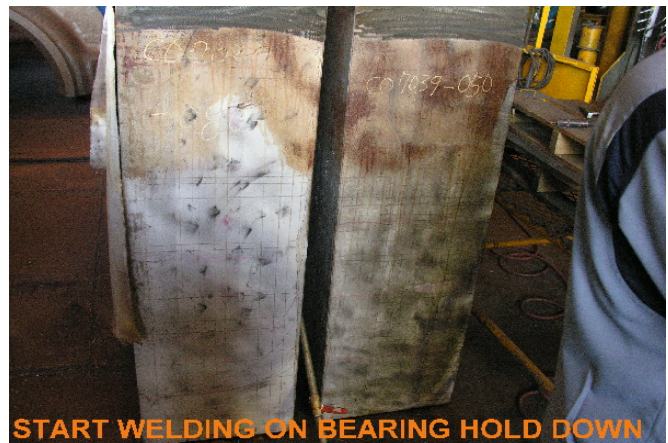
On this date DHIC has started repair welding on castings, QA inspector, HMIC QC Inspector and DHIC QC inspector has checked welding parameters prior start repair welding. DHIC used listed qualified welder Mr. DJ Kang, Mr. G. S. Kim, and Mr. J. H. Kim. Welding process utilized Gas Shielded Flux Core Arc Welding (FCAW-G) with E81T1-K2, 1.6mm diameter Manufacture by SEAH-ESAB, Brand name Dual shield 1181-K2. QA inspector checked welding parameters 23-26 volts, 210-250 amps, travel speed 13-16 cm/min, Gas flow 10-25l/min, preheat temperature over 100°C and 24 hours maintaining preheat temperature. All of welding parameters were found to comply with approved welding procedure specification A-F-Z1Z1-219.
